# ESCRI-SA Ongoing Performance 6 Monthly Operational Report

ESCRI-SA Knowledge Sharing Reference Group

3 March 2020

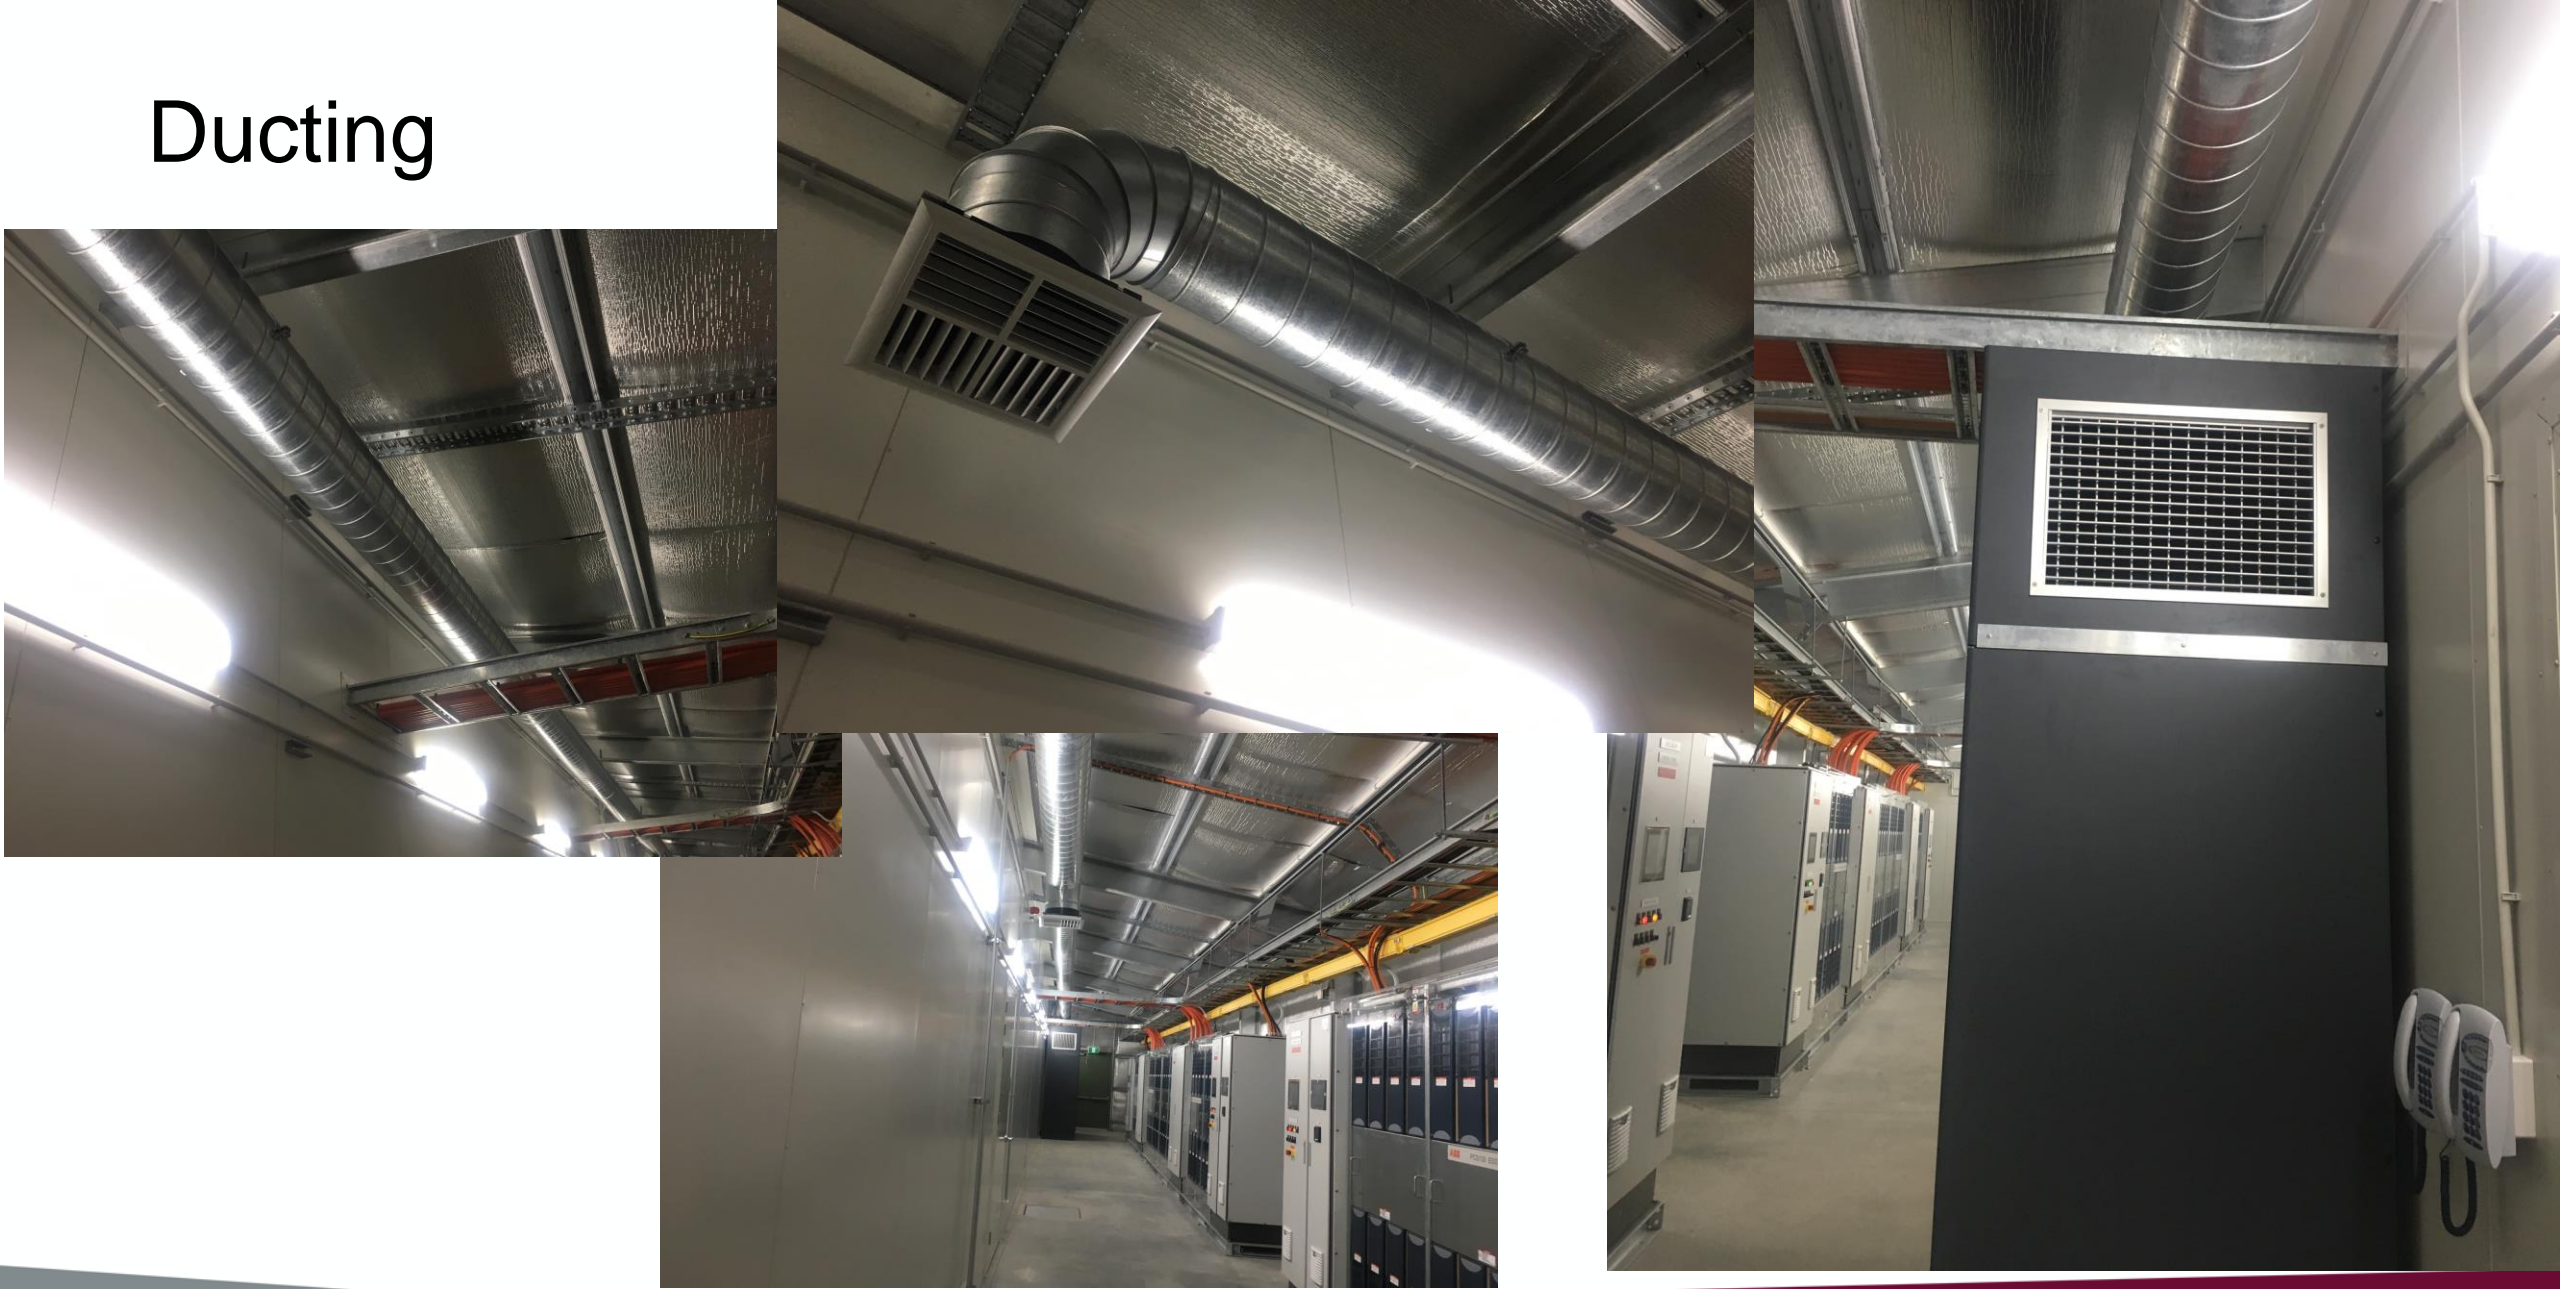
# Ducting

- Some continued issues with the air conditioning units and heat load (2 additional 100 kWt units installed, another 2 additional units ordered and some breakdowns)
- Mainly related to the inverter rooms, not the battery rooms, leading to some slight power derating on very hot days (Note: Dalrymple experiences days of very high ambient temp, above 40 degC)
- Seems to be an airflow / distribution microclimate issue – more / better directed ducting?

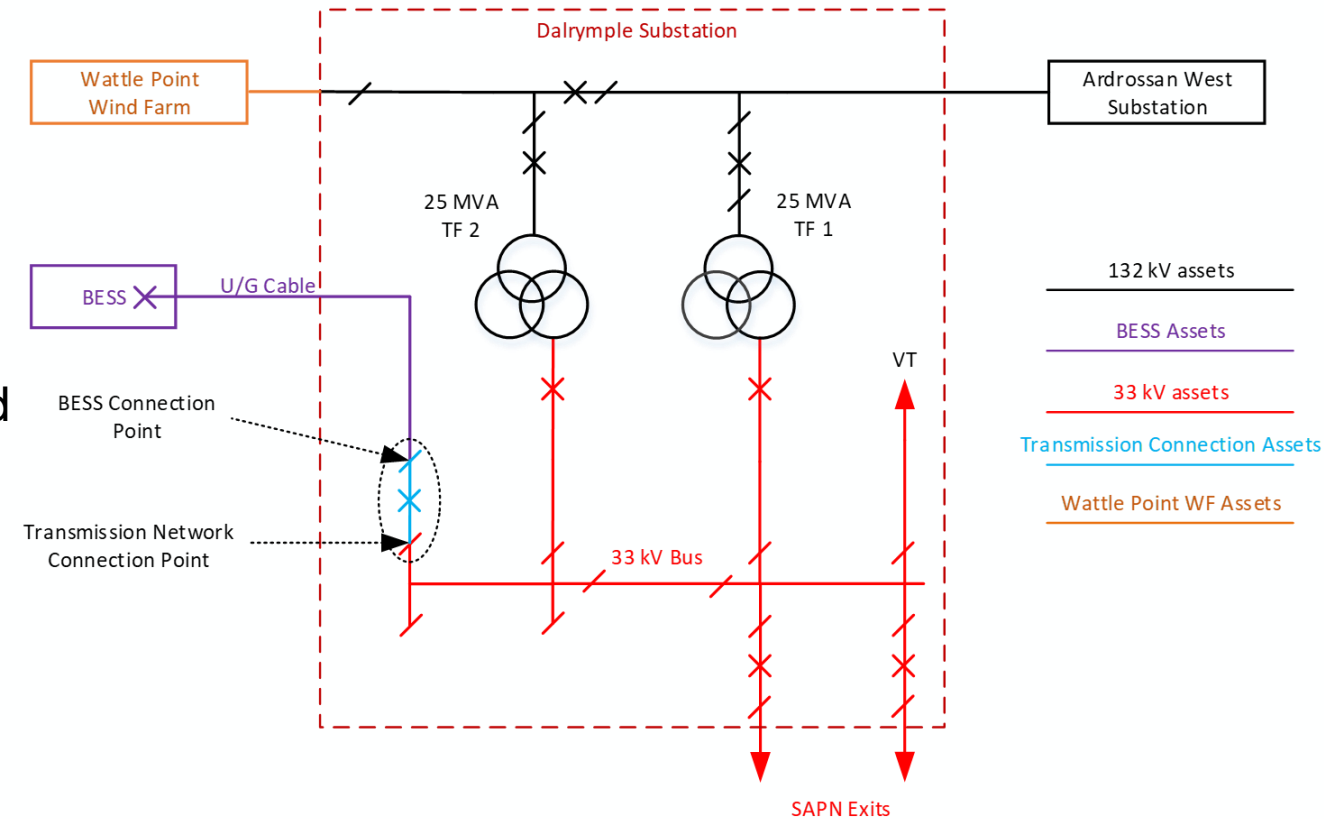
# Unplanned outage of the ESCRI-SA BESS on 13 June 2019

- On 13 June 2019, during protection tests at WPWF, a direct inter-trip signal to Dalrymple was accidentally initiated. This resulted in the Dalrymple 132/33 kV TF2 tripping and subsequent maloperation of the IDS resulted in the tripping of Dalrymple 132/33 kV TF1.
- The BESS successfully transitioned to islanded operation and continued to supply the local load until the System Operator restored all outage elements approximately half an hour later. No load was lost as a result of the incident.
- No planned or unplanned outages relevant to the ESCRI-SA BESS occurred during the second six months of commercial operation

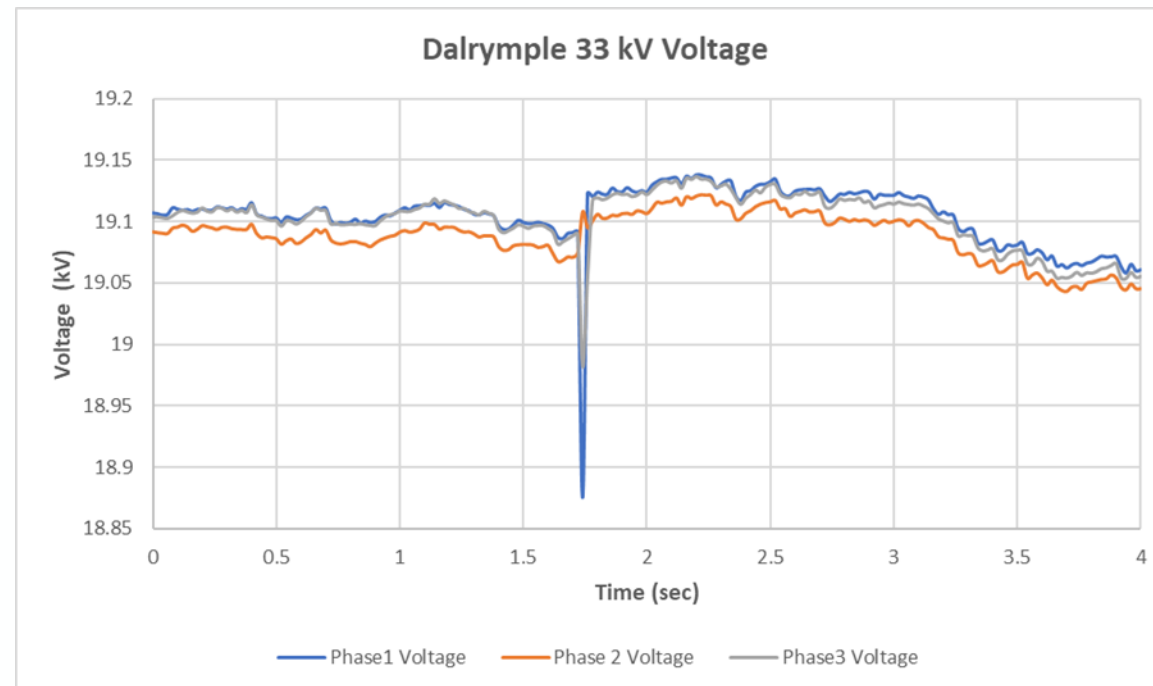
# Davenport – Olympic Dam 275 kV line fault on 1 September 2019

- On 1 September 2019 at 17:57, a single phase to ground fault occurred on the Davenport - Olympic Dam West 275 kV line. The fault was cleared and the line successfully reclosed. ESCRI-SA successfully rode through the fault as shown below.

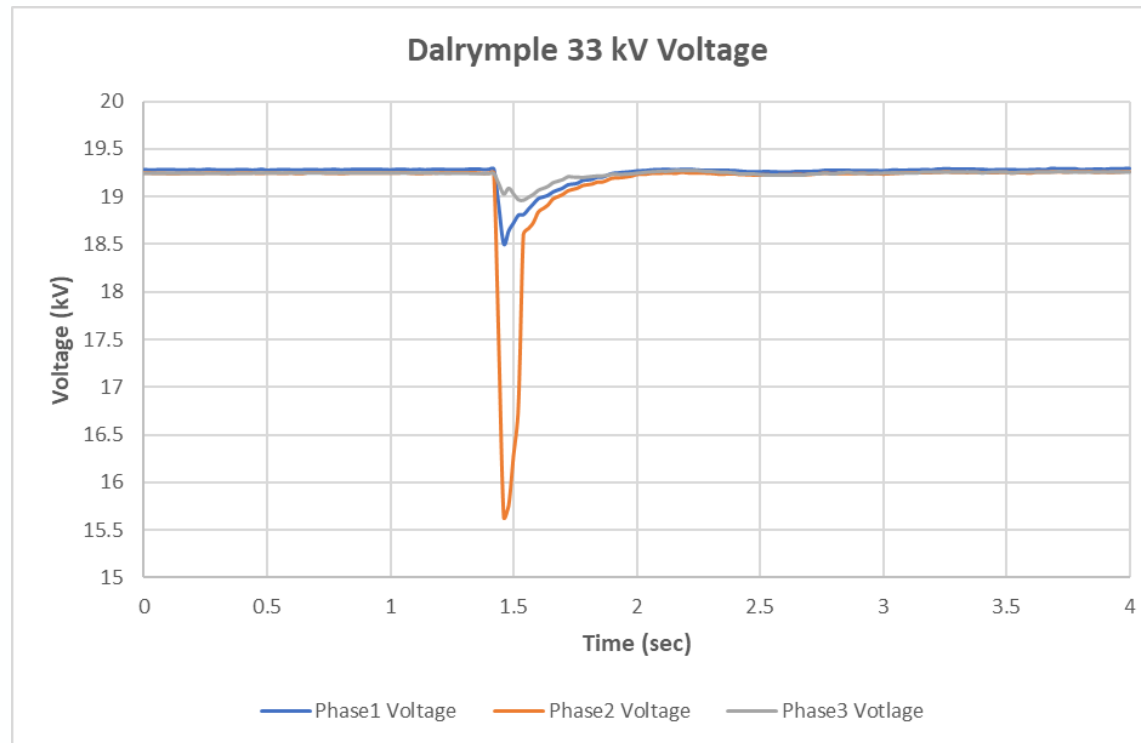
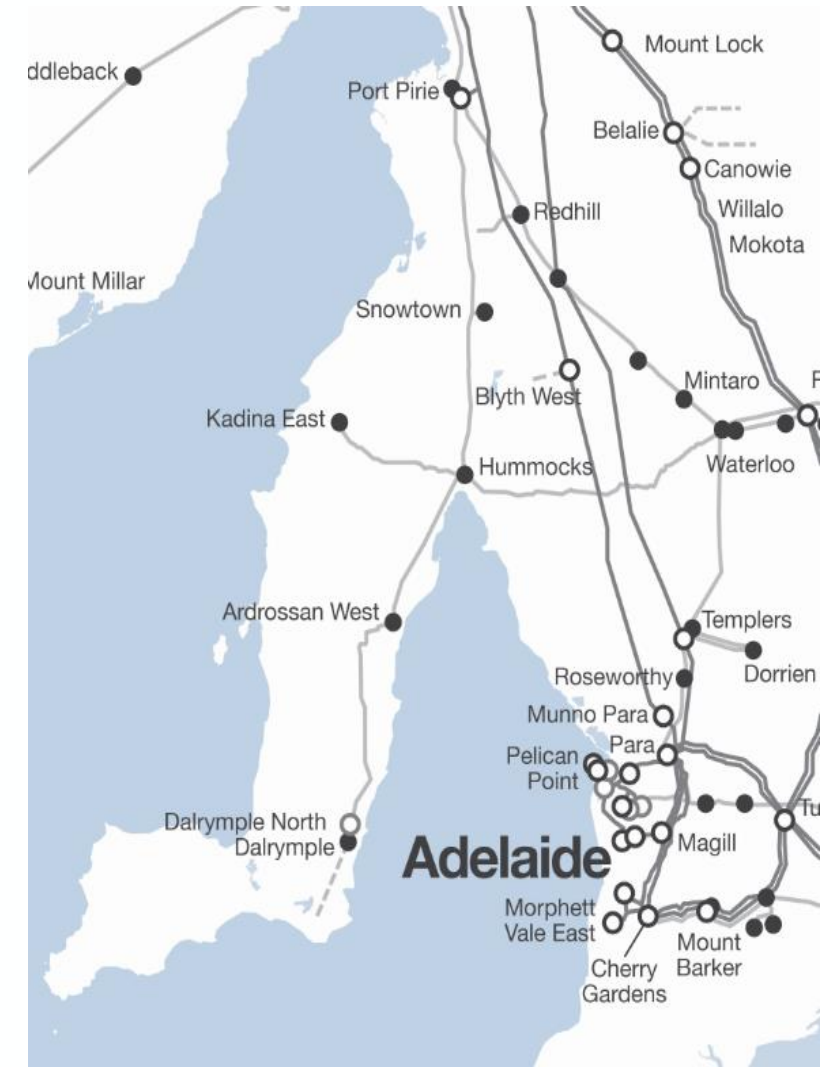
# Hummocks – Waterloo 132 kV line fault on 6 October 2019

- On 6 October 2019 at 03:35, a single phase to ground fault occurred on the Hummocks – Waterloo 132 kV line. The fault was cleared and the line successfully reclosed. High speed data recorded at the Dalrymple 33kV bus indicated the Dalrymple BESS successfully rode through the fault as shown below.

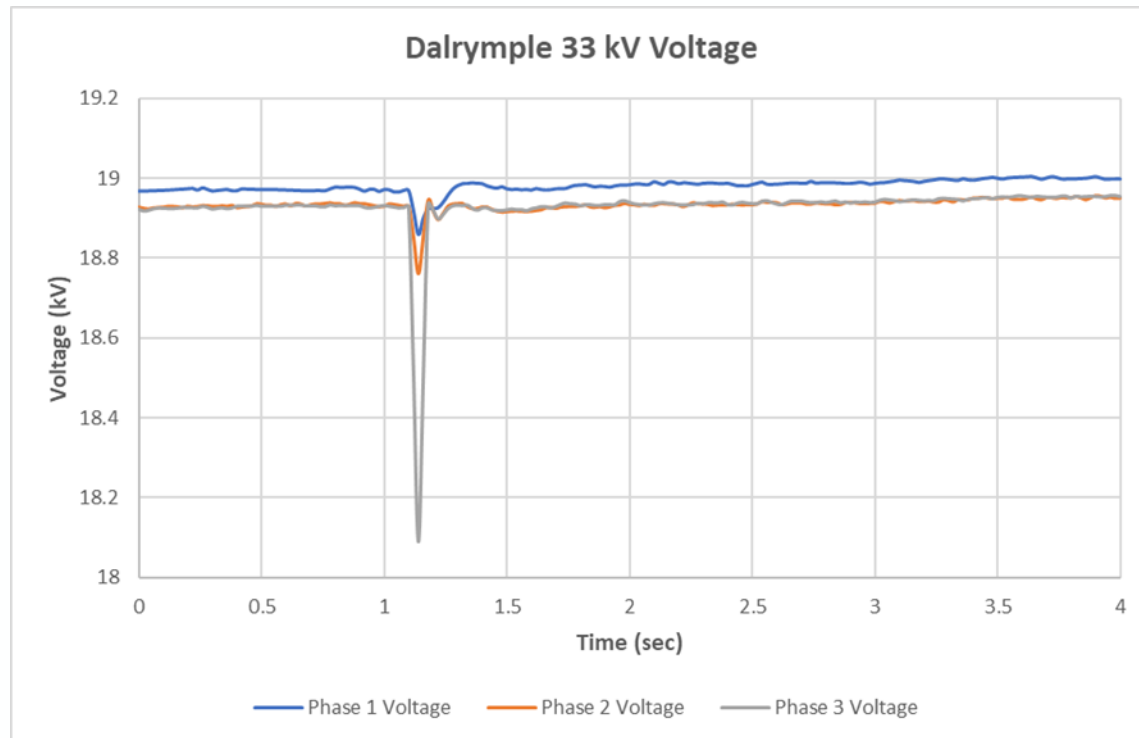
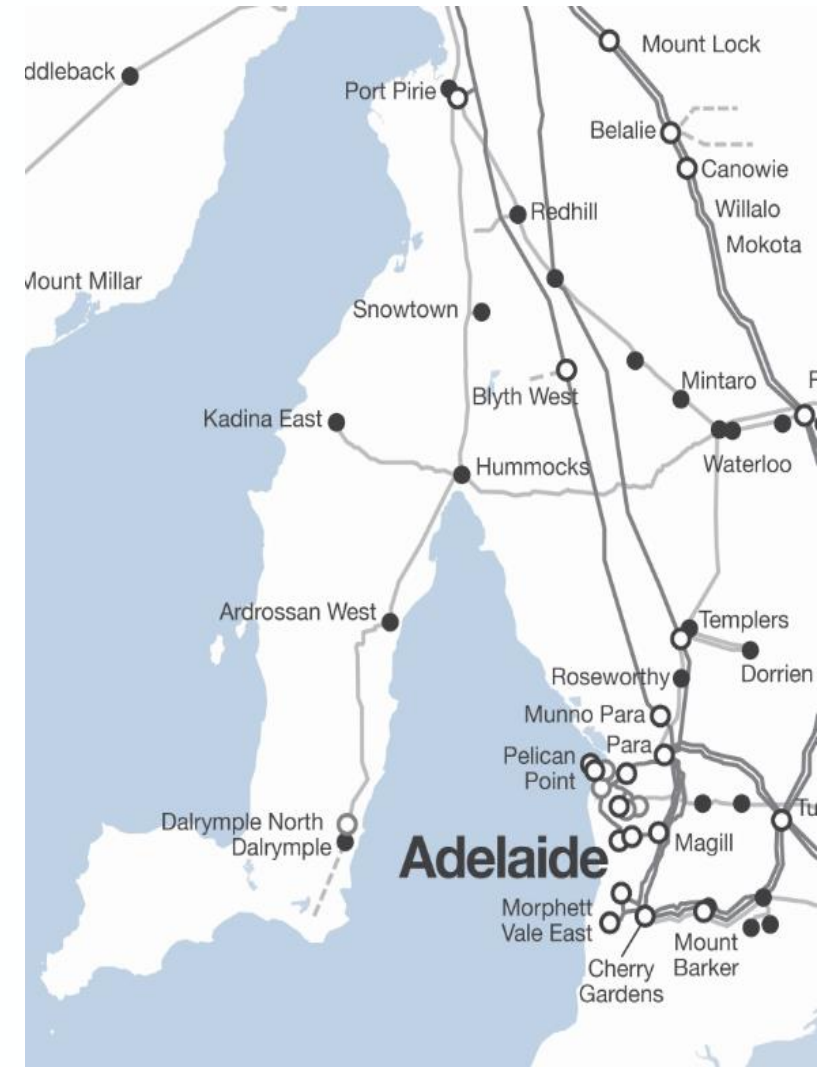
# Waterloo – Templers 132 kV line fault 1 November 2019

- On 1 November 2019 at 20:20, a single phase to ground fault occurred on the Waterloo – Templers 132 kV line. The fault was cleared and the line successfully reclosed. High speed data recorded at the Dalrymple 33kV bus indicated the Dalrymple BESS successfully rode through the fault as shown below.

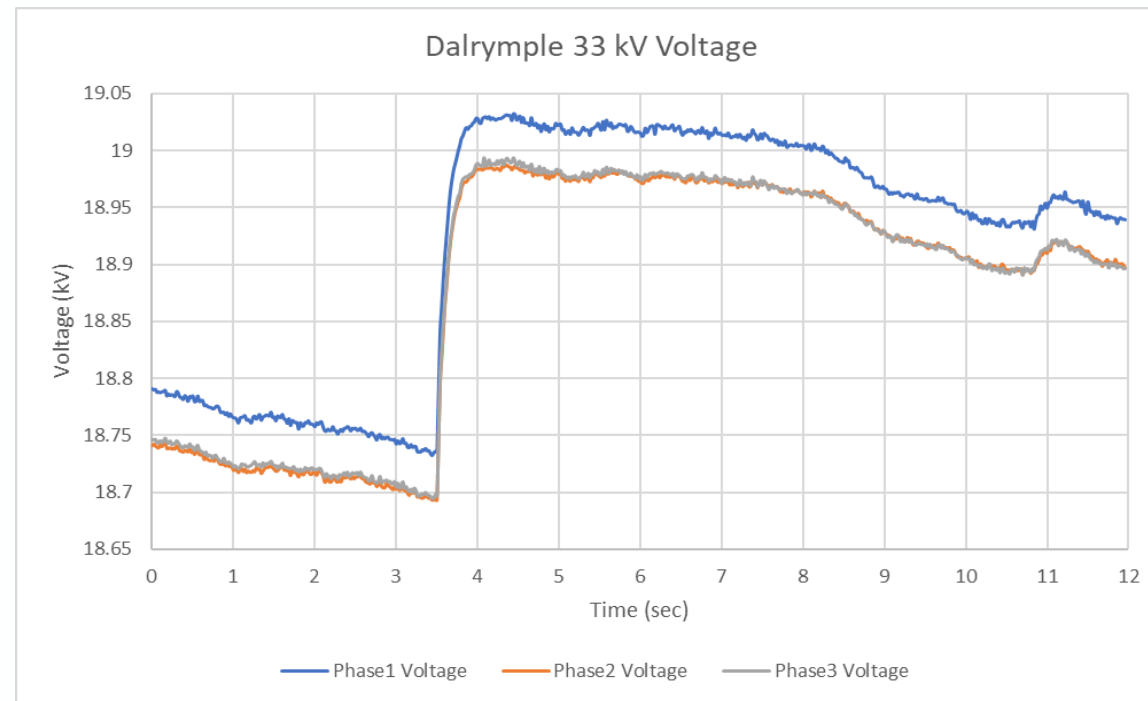
# Monash – Berri #2 132 kV line Fault - MurrayLink sever tripped

- On 1 November 2019 at 23:20, a single phase to ground fault occurred on the Monash - Berrie # 2 132 kV line. The fault was cleared and the line successfully reclosed, whilst North West Bend – Monash #1 line was out of service. As a result of the fault, MurrayLink was tripped. High speed data recorded at the Dalrymple 33kV bus indicated the Dalrymple BESS successfully rode through the fault as shown below.

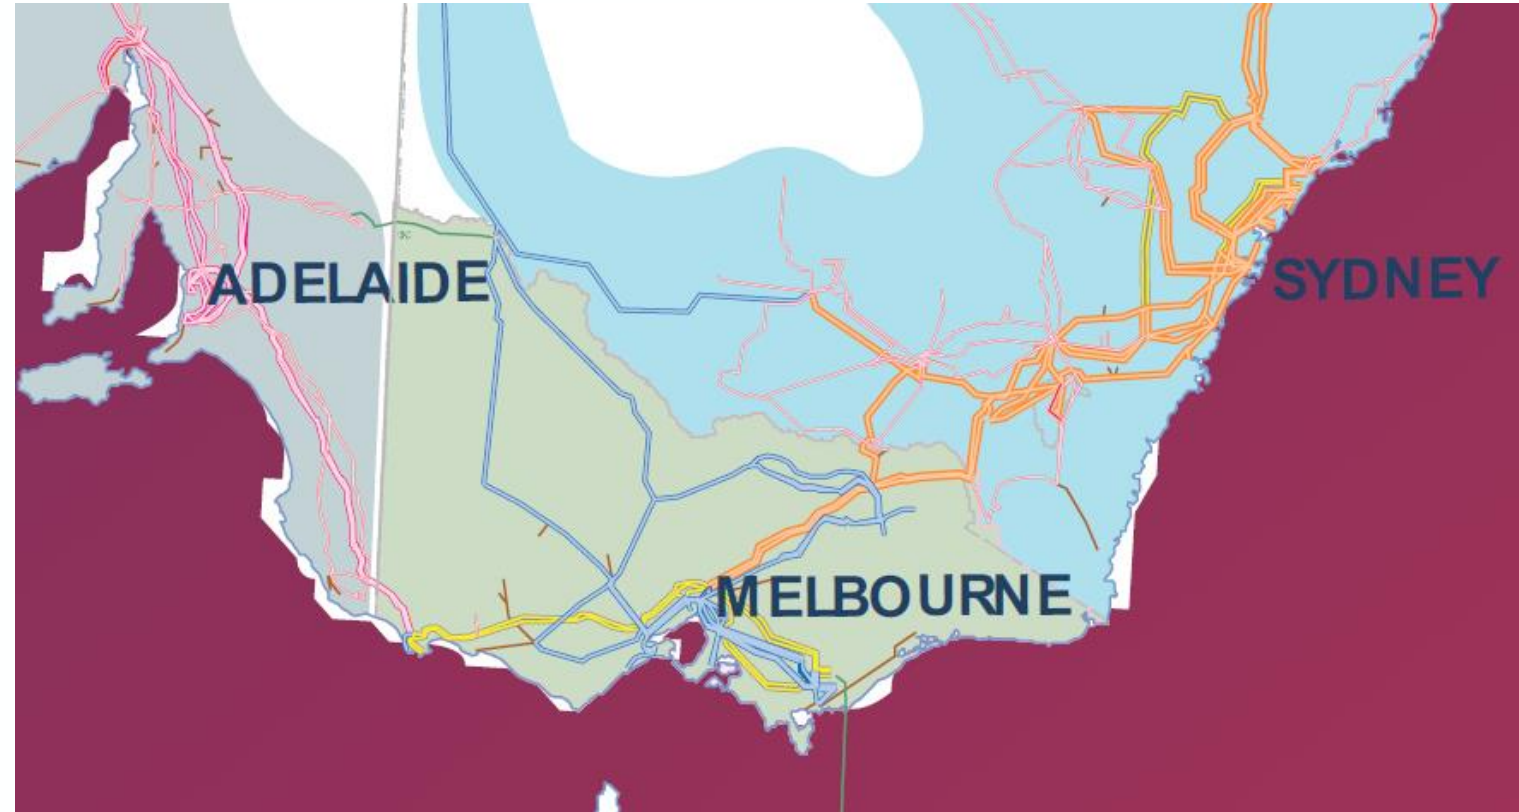
# Heywood Interconnector tripped on 16 November 2019

- On 16 November 2019 at 18:06, the 500 kV double circuits between Heywood and Moorabool were tripped as the result of a fault. The Heywood interconnection between South Australia and Victoria was lost and the SA transmission network transitioned to an islanded condition with SA exporting approximately 300 MW at the time of the event. High speed data recorded at the Dalrymple 33kV bus indicated the Dalrymple BESS responded to the event as shown below.

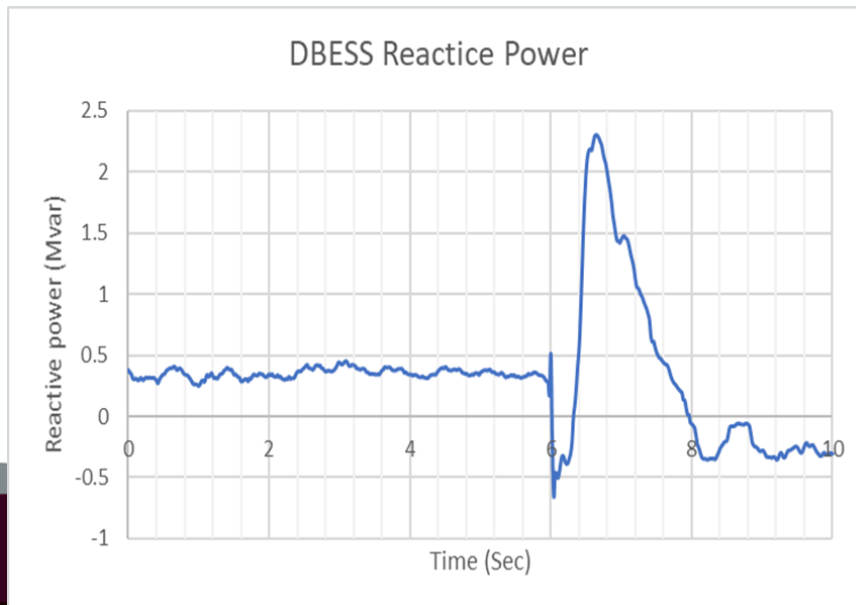
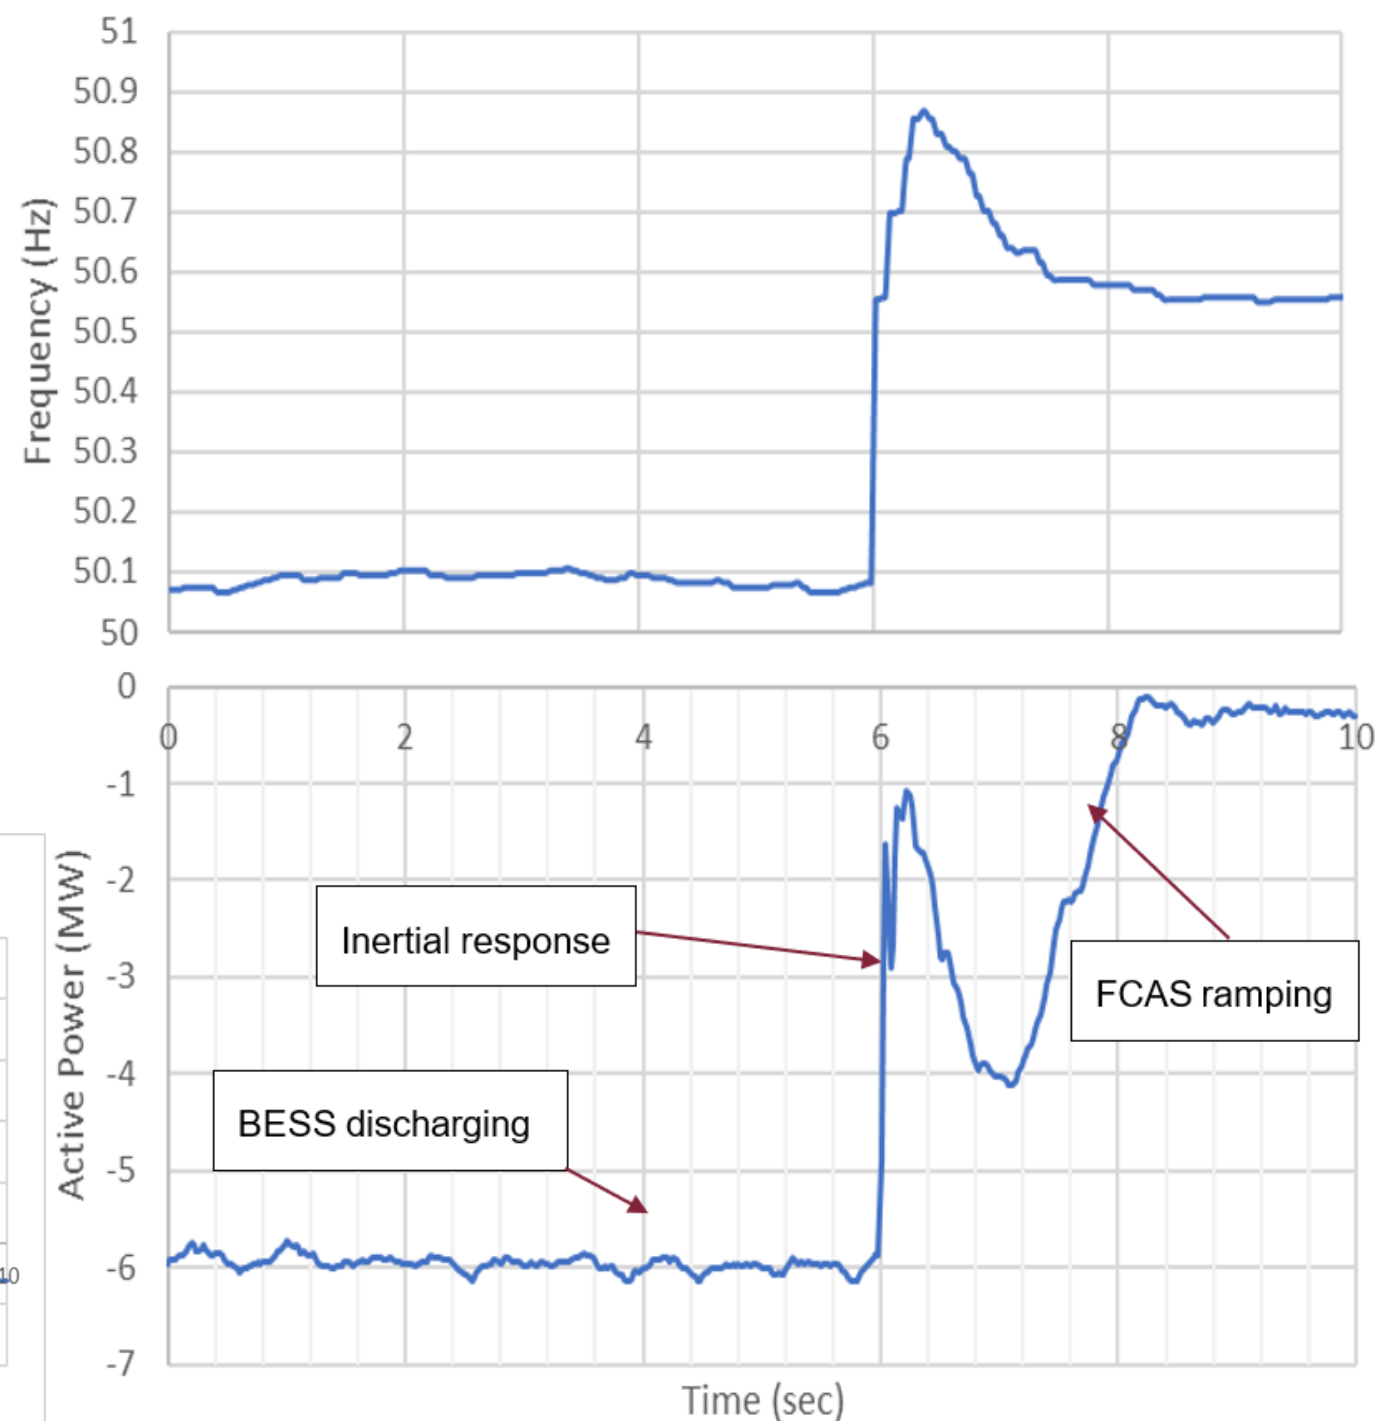
# SA Islanding from NEM

- On 16 November 2019 at 18:06, the 500 kV double circuits between Heywood and Moorabool tripped
- The Heywood interconnection between South Australia and Victoria was lost and the SA transmission network transitioned to an islanded condition with SA exporting approximately 300 MW at the time of the event
