# ESCRI-SA Ongoing performance

ESCRI Knowledge Sharing Reference Group

12 June 2019

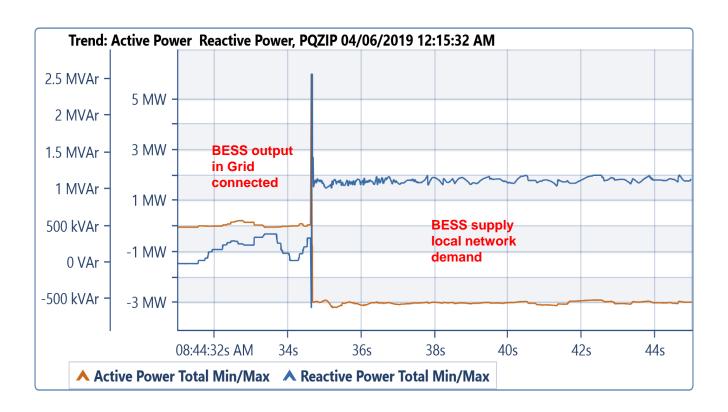
### 29 March 2019 Incident

- > IDS mal-operation during network switching
  - ElectraNet carried out line switching at Ardrossan West
  - IDS operated due to incorrect logic in Ardrossan West IDS unit
  - IDS operated cause tripping of 132 and 33 kV CB at Dalrymple
  - Dalrymple BESS went to islanding operation to supply Dalrymple load for 30 minutes
  - Dalrymple load at the was approximately 3 MW
  - No load was lost to the lower Yorke Peninsula region during the 30 minute outage
  - Successfully re-synch with the system

#### > BESS PQ load

- > IDS logic has been fixed after the incident on 29 March 2019
- > Backup vector shift relay operation confirmed by ElectraNet study Vector shift relay operation has been isolated after the 7 April 2019 event.
- > The Dalrymple BESS successfully transitions from Grid connected to Islanded operation and supply local load without any issues.
- > The Dalrymple BESS can successfully ride through transmission network faults and provide significant reactive power to support network voltage during the fault.
- > The BESS is able to control islanded network voltage and frequency within the normal operating range.

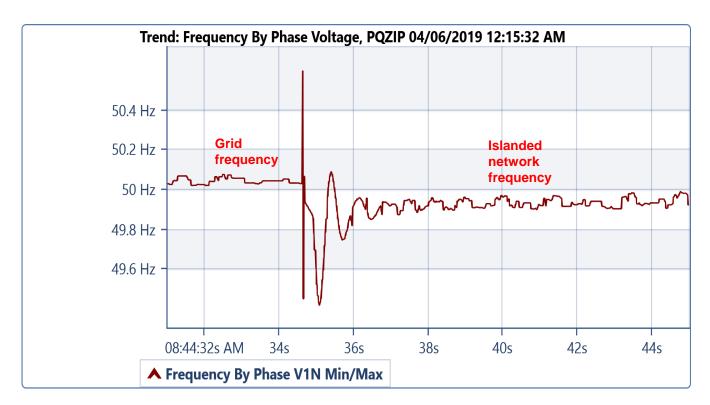
### 29 March 2019 Incident

Islanded Network Frequency

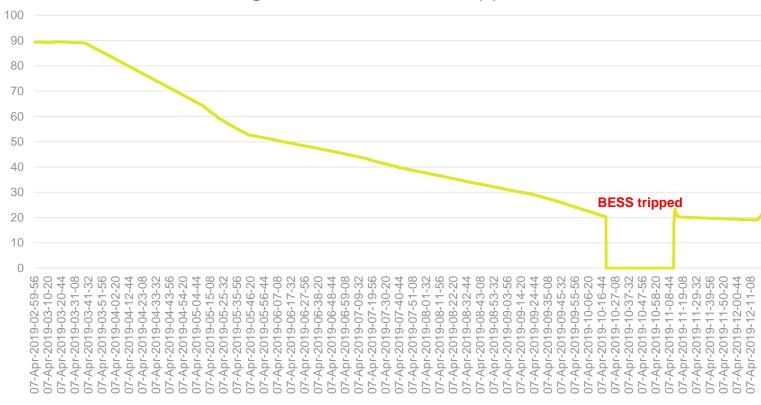
### 7 April 2019 Event

- > Dalrymple BESS tripped by vector shift relay
  - In the early hours of 7 April, ElectraNet carried out protection and isolator maintenance at Hummocks substation that required to have planned outage of the Yorke Peninsula 132 kV network
  - IDS was in non auto
  - Dalrymple BESS successfully transited to islanding operating condition
  - BESS supply local load 7 hours
  - Dalrymple local was approximately 1 MW
  - BESS tripped by vector shift relay when SAPN restored one of the 33 kV feeders resulting in a loss of supply for the last 30 minutes of the 7.5 hour outage

- > BESS State of Charge (SOC)
- Note: SCADA reading zero when BESS tripped offline

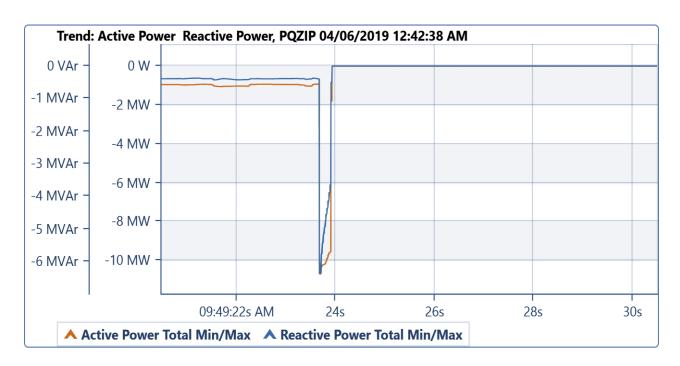
### 7 April 2019 Event

#### > PQ load of the BESS

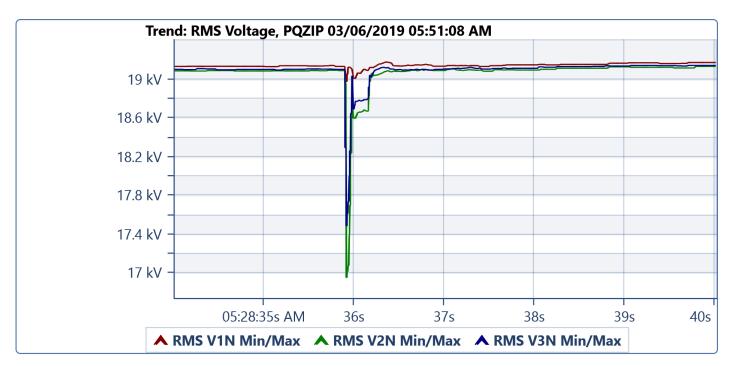
#### 2 Phase fault on the Mintaro – Waterloo 132 kV line at 5:29 on 4/3/2019

#### > Dalrymple BESS RMS Voltage

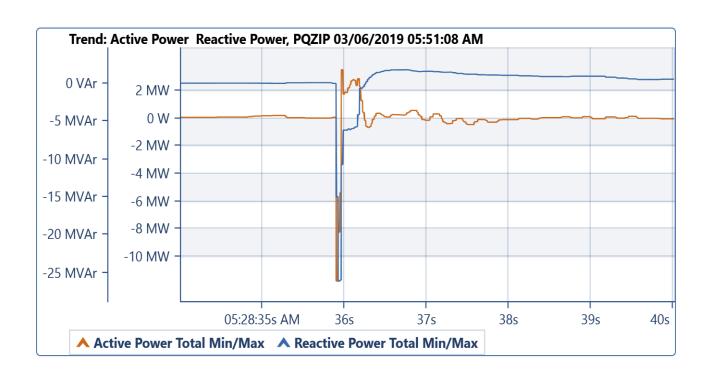
#### 2 Phase fault on the Mintaro – Waterloo 132 kV line at 5:29 on 4/3/2019

#### > Dalrymple BESS PQ Load

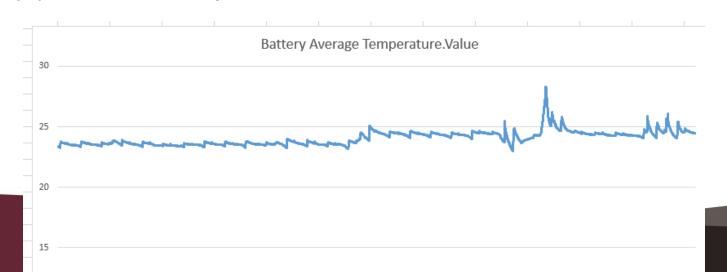
Month	1	2	3	4	5
Date From	14/12/2018	14/01/2019	14/02/2019	14/03/2019	14/04/2019
Date to	14/01/2019	14/02/2019	14/03/2019	14/04/2019	14/05/2019
Availability (%)	98.07	91.60	99.08	99.61	100

- > Contractual target of 96%
- > Actual performance has been good and improving
- > Month 2, poor performance due mainly to air conditioning issues during warm weather
- > Manual shutdown (full and part for a few days). Concerned that until the Air Con fault fixed, the additional heat load may impact the Air Cons or adversely impact the equipment in the battery/inverter rooms.
